# **Ecological Guidelines and Recommendations for Mula-Mutha Riverfront Development**

Ecological Guidelines  
and  
Recommendations  
For  
Mula-Mutha Riverfront Development

March 2018 (revised)

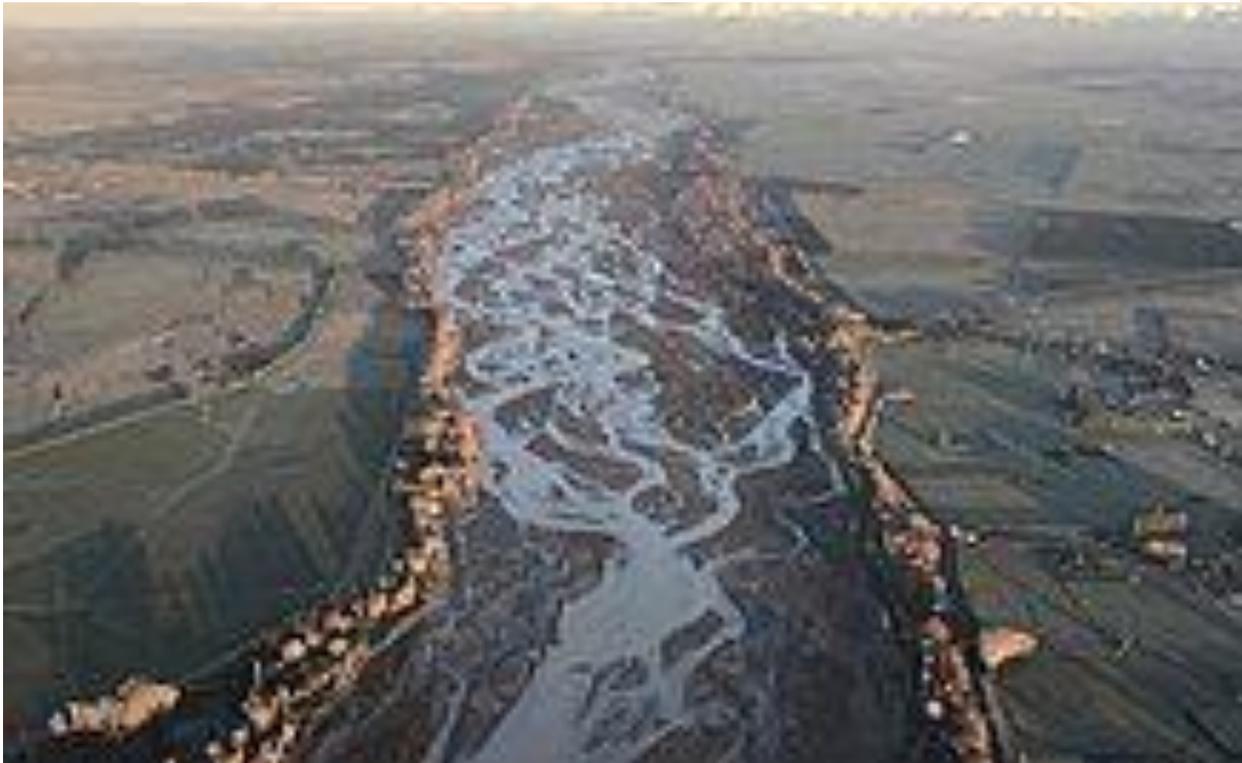
**Example of a braided river** (Source : Greg O'Beirne, Wikipedia under CC license)

River is channelized right from the Warje Bridge. This constructed channel flow continuous even beyond Vithalwadi till Rajaram Bridge. Beyond Rajaram Bridge two tributary streams join the main Mutha river. These two streams also separately flow in constructed channel and there are bunch of three constructed channels looking like a braided river is seen in this area. The Natural channel floor is very wide in this

zone. Riparian vegetation is observed along both the banks. River channel is braided in this zone. Residential land use is prominent along the right bank, whereas party lawns, private, public open spaces and residential land use present along the left bank. Many micro habitats and wetlands are formed along the channel created by sewage water coming from the above mentioned commercial area.

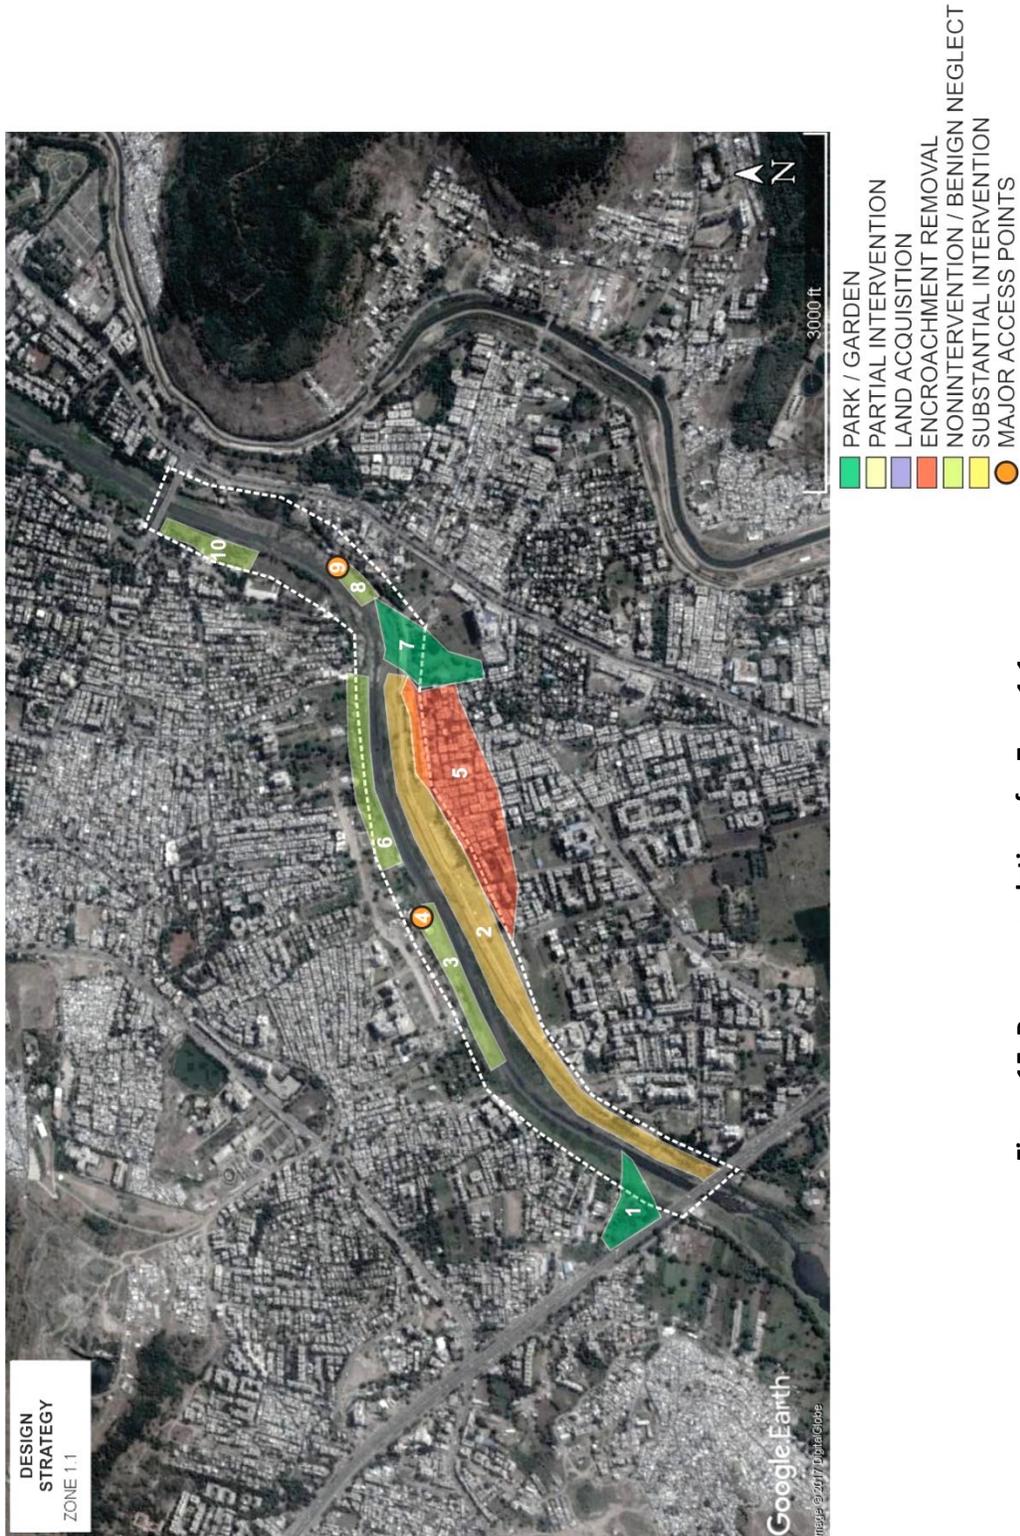
Figure 15: Recommendations for Zone 1.1

**A. Zone 1.1** (Refer to the figure 15)

This is a patch in front of the crematorium in Vitthalwadi. Once the access is restricted, it will be an ideal location for developing Riparian vegetation.

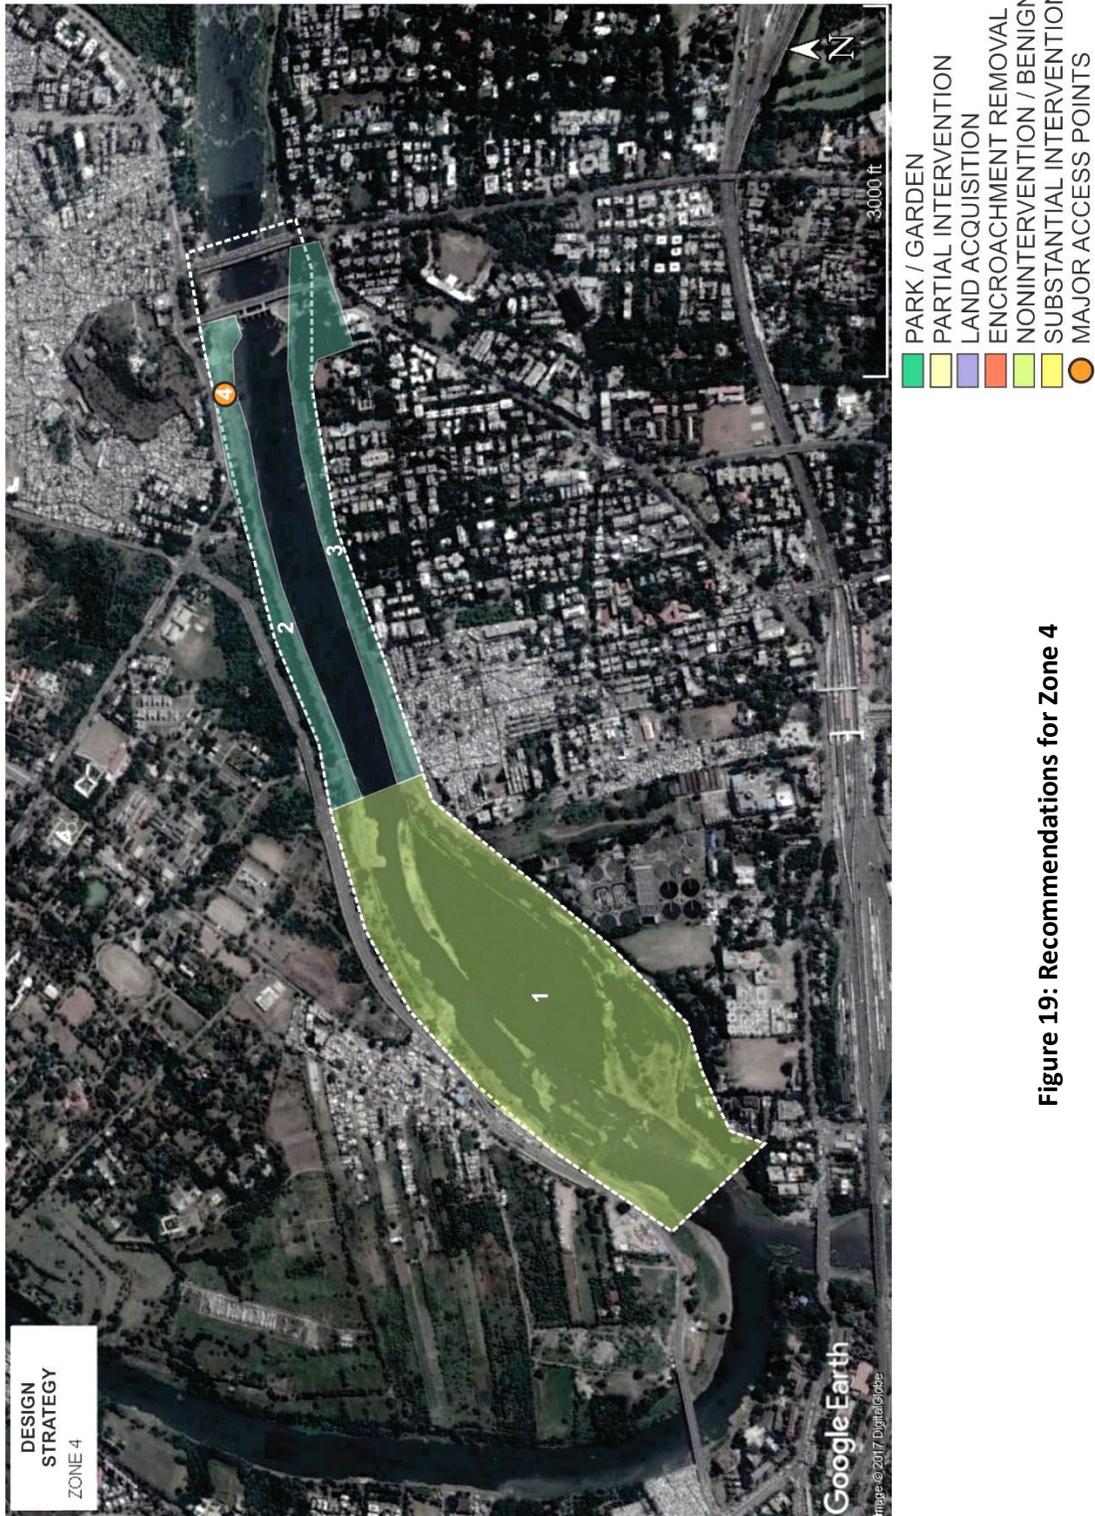
Figure 19: Recommendations for Zone 4

**E. Zone 4** (Refer to Figure 19)

3. Point 4 This is a temple at the start of the jogging track near the Bund garden bridge, on the left bank of the Mula-Mutha. It also has a visarjan ghat. This place can be developed into an important access point to the river.

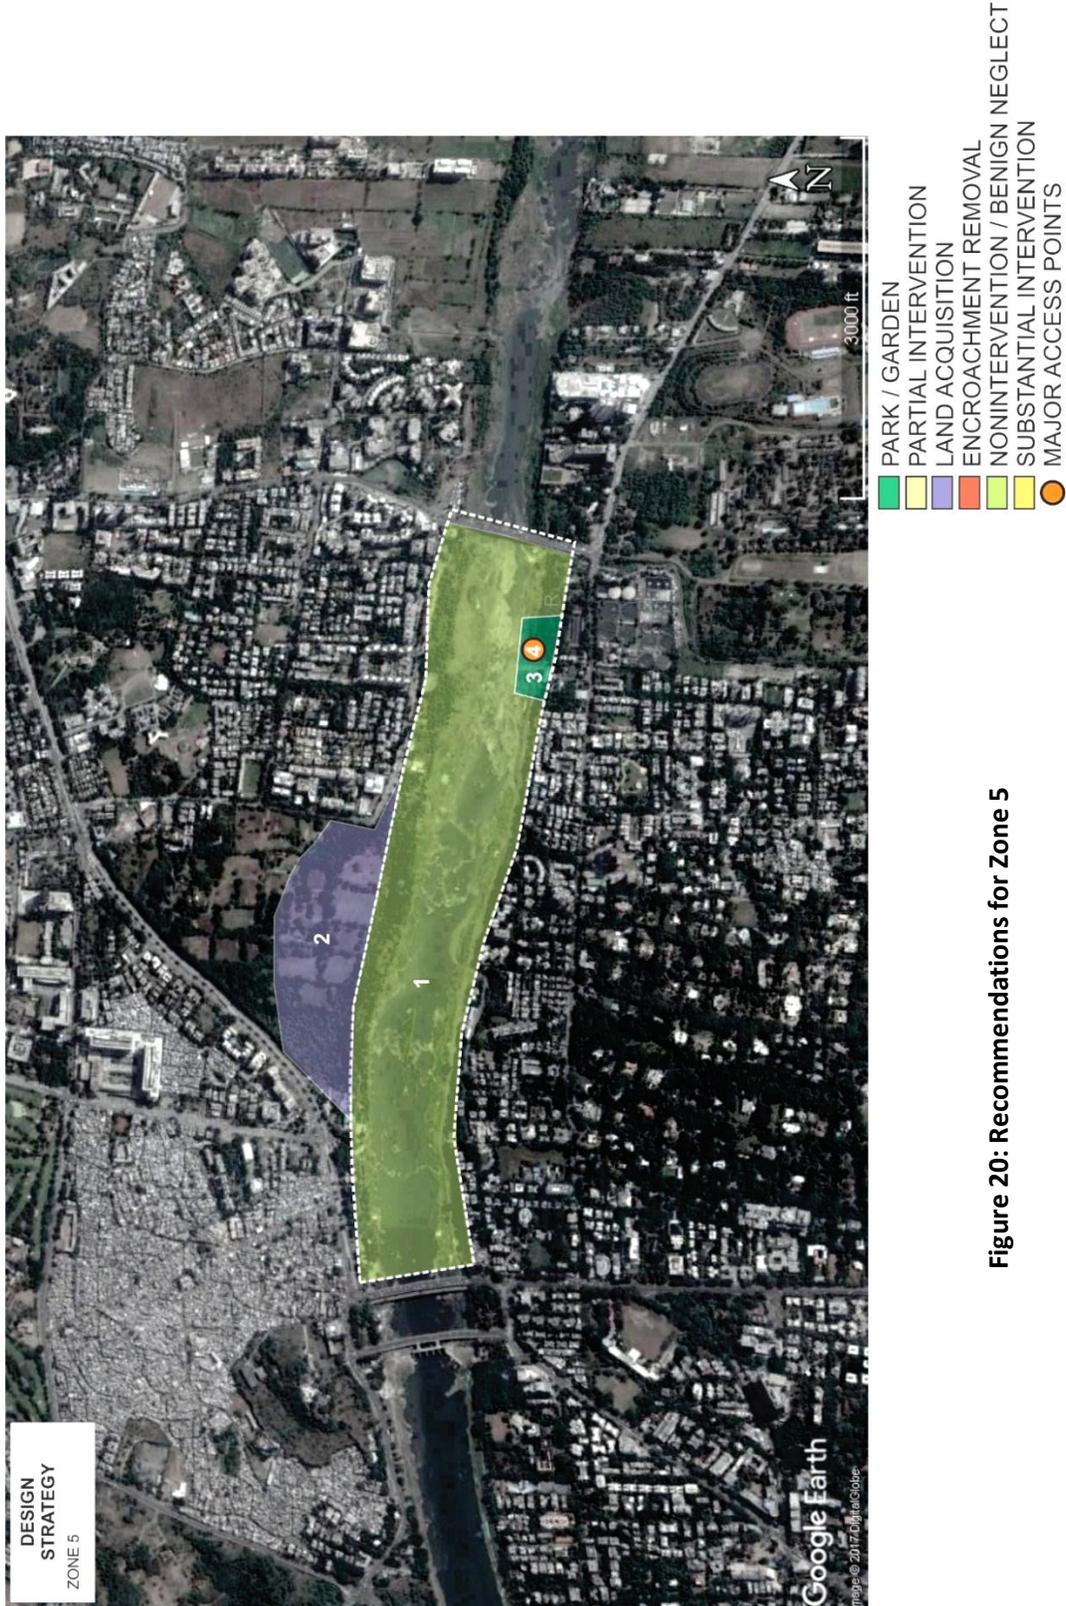
Figure 20: Recommendations for Zone 5

**F. Zone 5 (Refer to Figure 20)**
